**Remedial Investigation and Removal Action Work Plan for
Riverside Park – Draft RI Results Addendum
Libby Asbestos Site, Operable Unit 4**

September 26, 2003

**Work Assignment No.: 137-RIRI-08BC
Document Control No.: 3282-137-PP-SAMP-XXXXX**

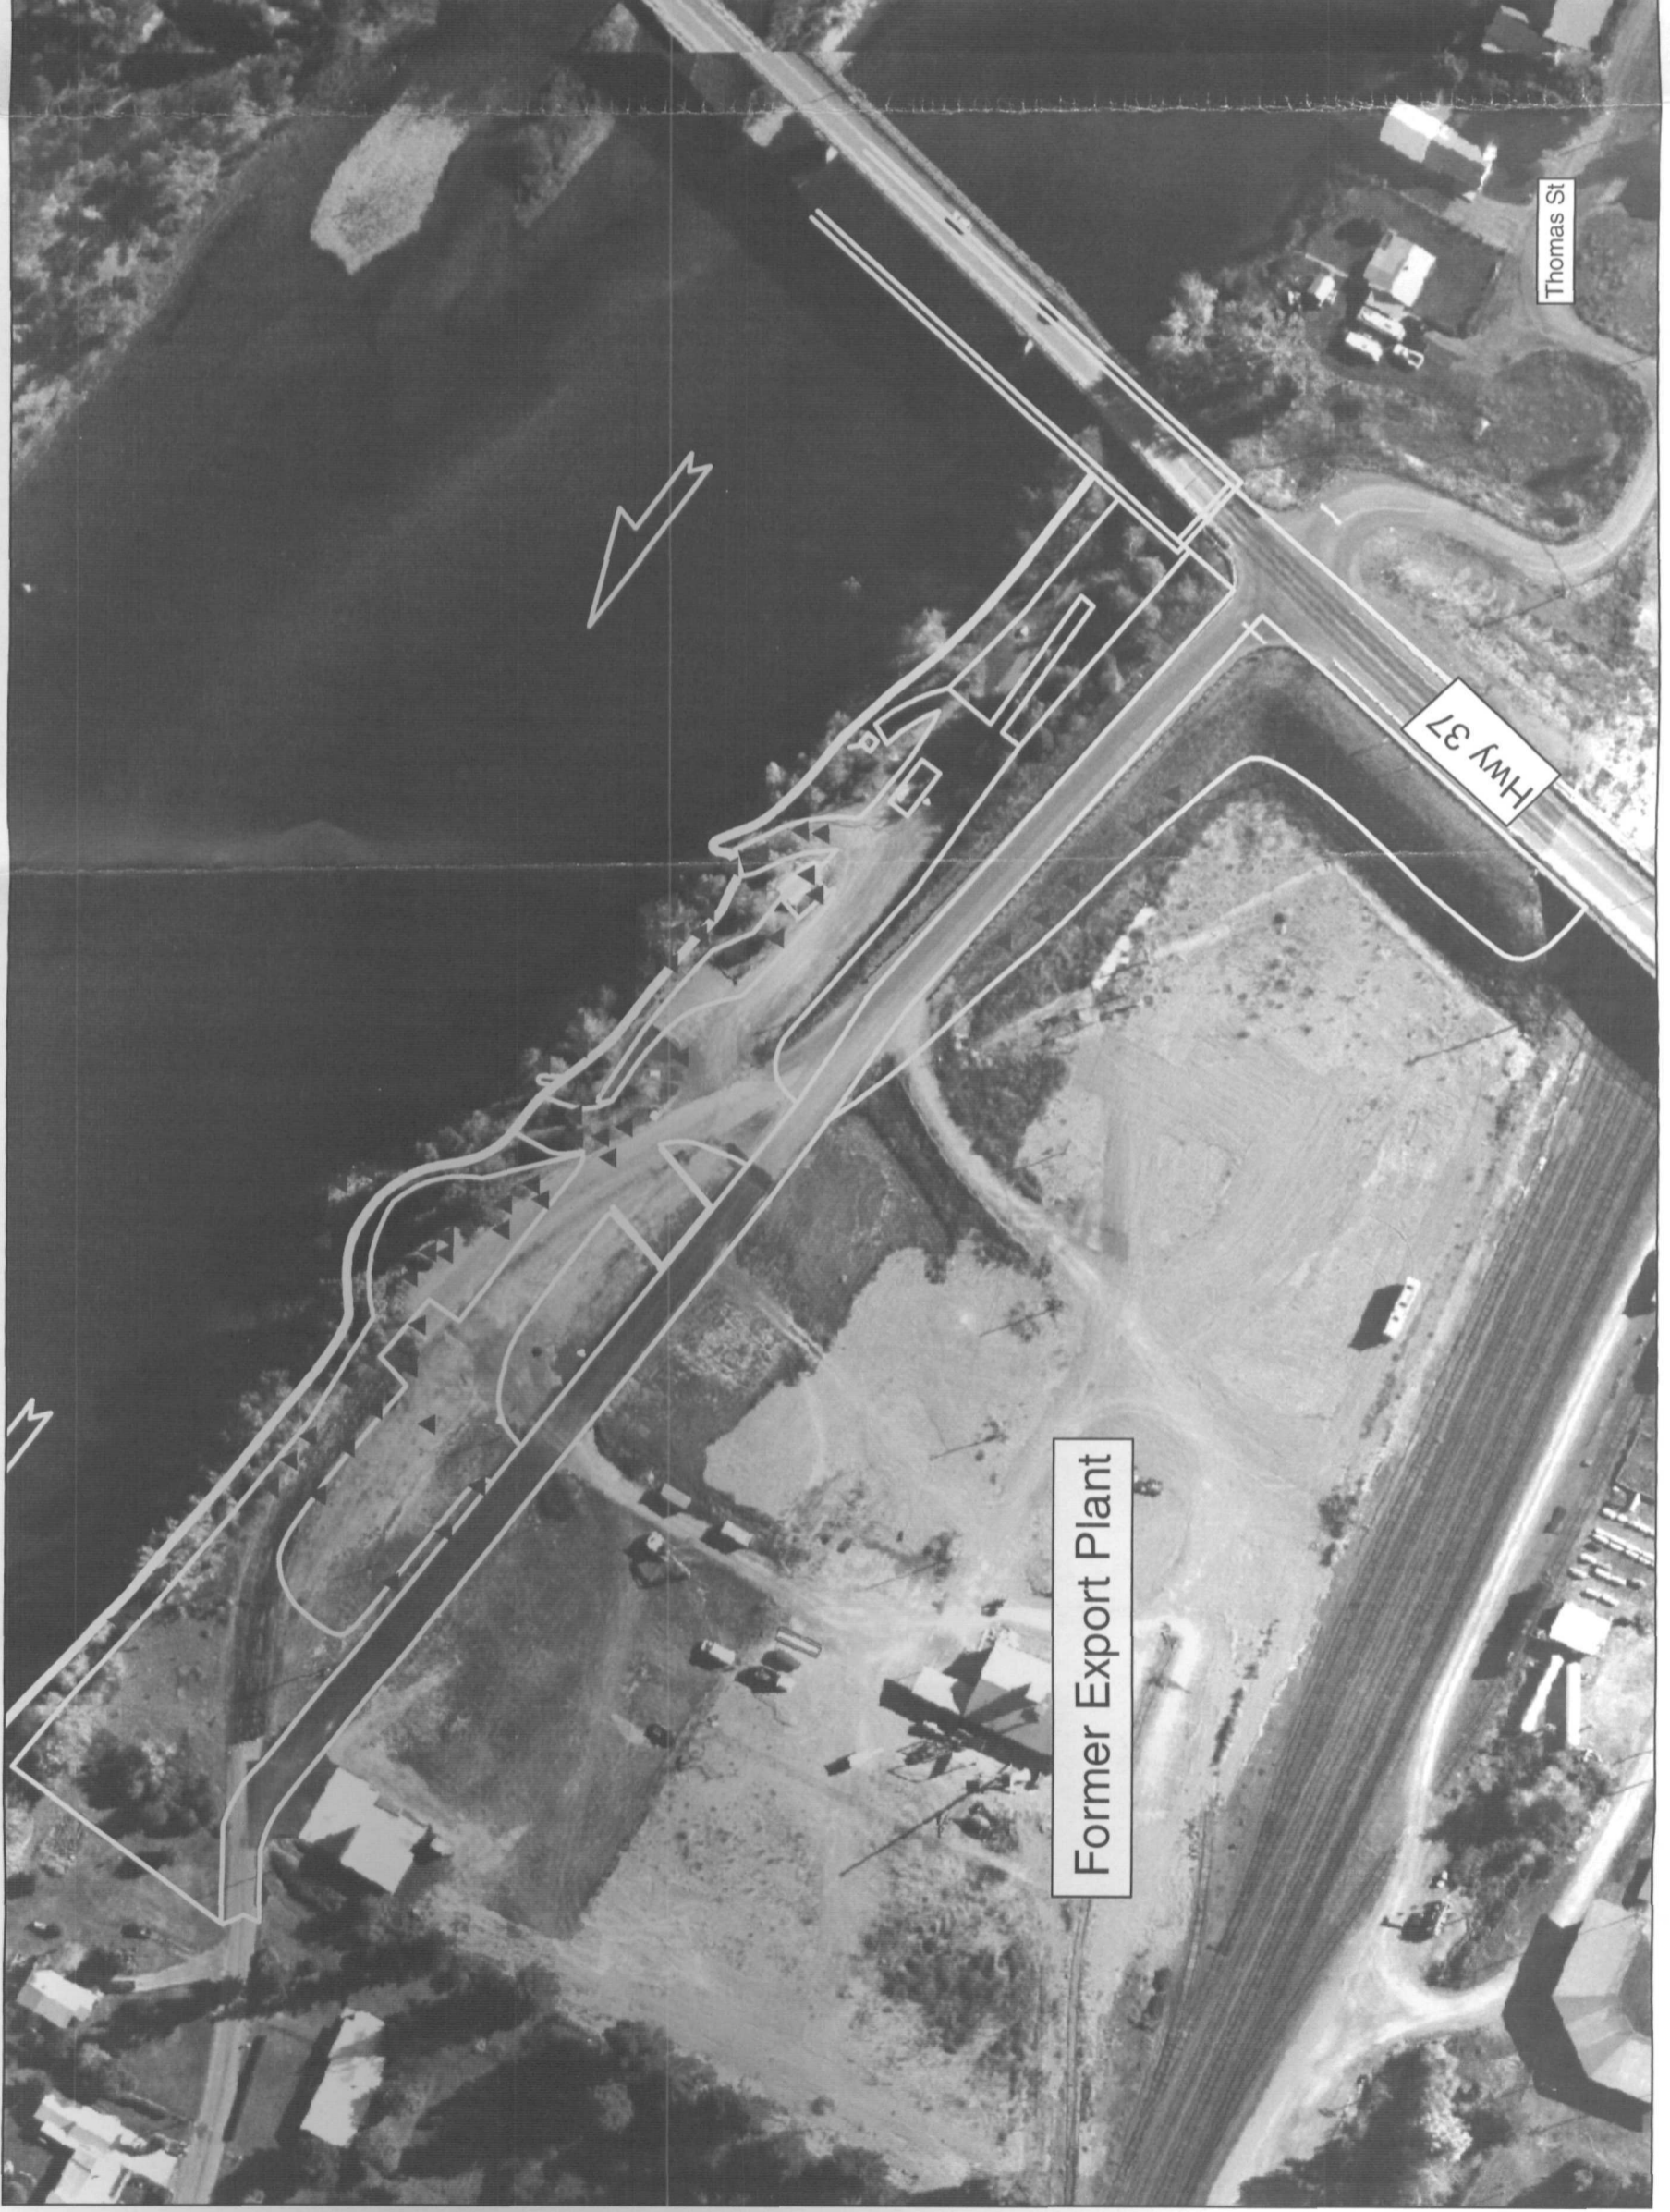
Figure 2-1
Visible Vermiculite
Location Map
Riverside Park
Libby, Montana

CDM conducted an initial inspection of the site on May 22, 2003. Details regarding that inspection can be found in the remedial investigation and removal action work plan (CDM 2003a). Additional inspections were completed between September 9 and 13, 2003. Vermiculite was observed at several locations within the park, but was generally concentrated in areas on the river side of the former access road that ran through the property including the entire length of the riverbank. Trace to moderate amounts of vermiculite were also observed on the South West side of the embankment (export plant side) of City Service Road. Lastly, an isolated area of vermiculite was located at the bottom of the embankment of West Thomas Street on the east side of Highway 37. All locations of vermiculite found during visual inspections are shown of Figure 2-1. Logbook pages from the work at Riverside Park can be found in Appendix B.

The visual inspection of the site indicated that visible vermiculite is pervasive at the surface on the river side of the former access road that ran through the property including the entire length of the riverbank. It was also identified at other locations in the park and on the South West side of the embankment of City Service Road immediately west of Highway 37 (see Figure 2-1).

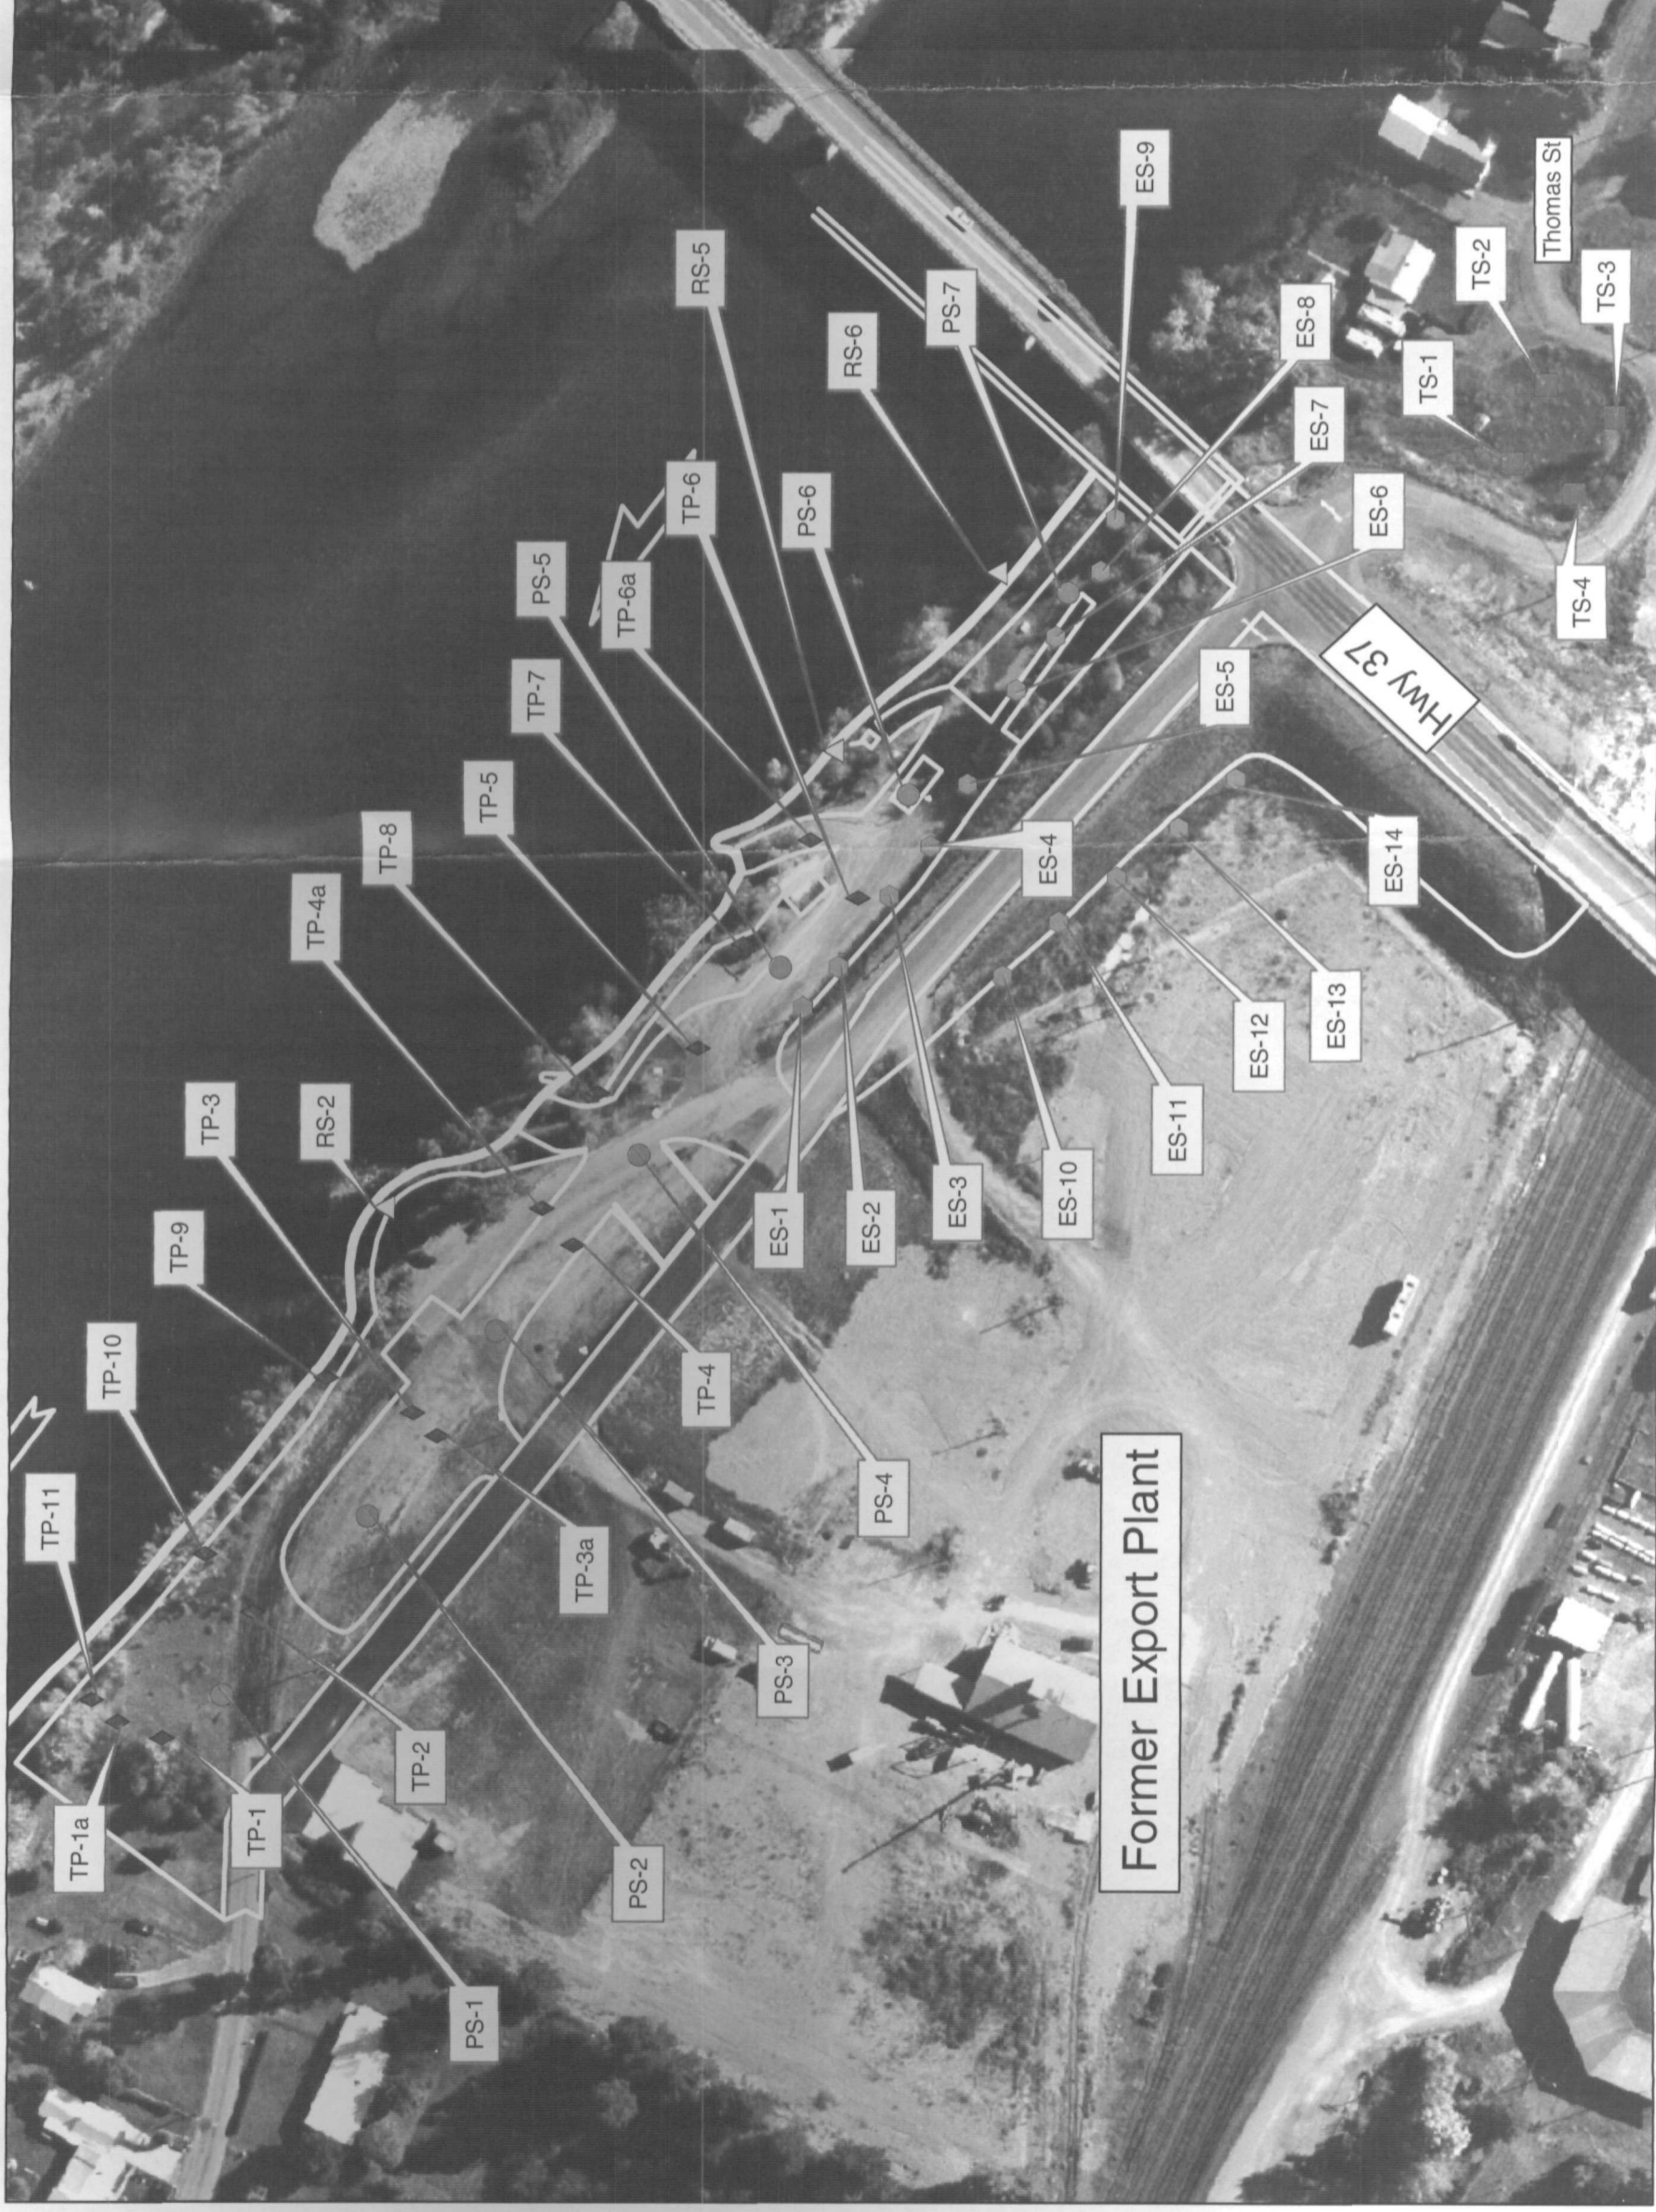
Figure 2-2
Sample Location Map
Riverside Park
Libby, Montana

Seven surface soil samples were collected within the park (Figure 2-2). All proposed sampling locations were sampled (i.e., no locations needed to be either deleted or moved due to visible vermiculite) and no additional samples were collected. Visible

vermiculite was observed near sample locations (CS-16687 and CS-16688); however, no vermiculite was seen in either sample collected at those locations.

Three surface soil samples were collected along the riverbank on the north side of the park (Figure 2-2). Information regarding the remaining four proposed riverbank samples (RS-1, RS-3, RS-4, and RS-7) is discussed in Section 3.1.

Nine surface soil samples were collected on the north and five surface samples were collected on the south side of the embankment of City Service Road between Highway 37 and the entrance to the park (Figure 2-2). Embankment samples were collected at 50-foot intervals as described in the remedial investigation and removal action work plan (CDM 2003a). Figure 2-1 of the work plan showed eight sample locations, however, sampling at 50-foot intervals resulted in fourteen sample locations. Trace to moderate amounts of vermiculite was observed on the South West side of the embankment (export plant side); conversely, no vermiculite was seen on the North East side of the embankment (Riverside Park side).

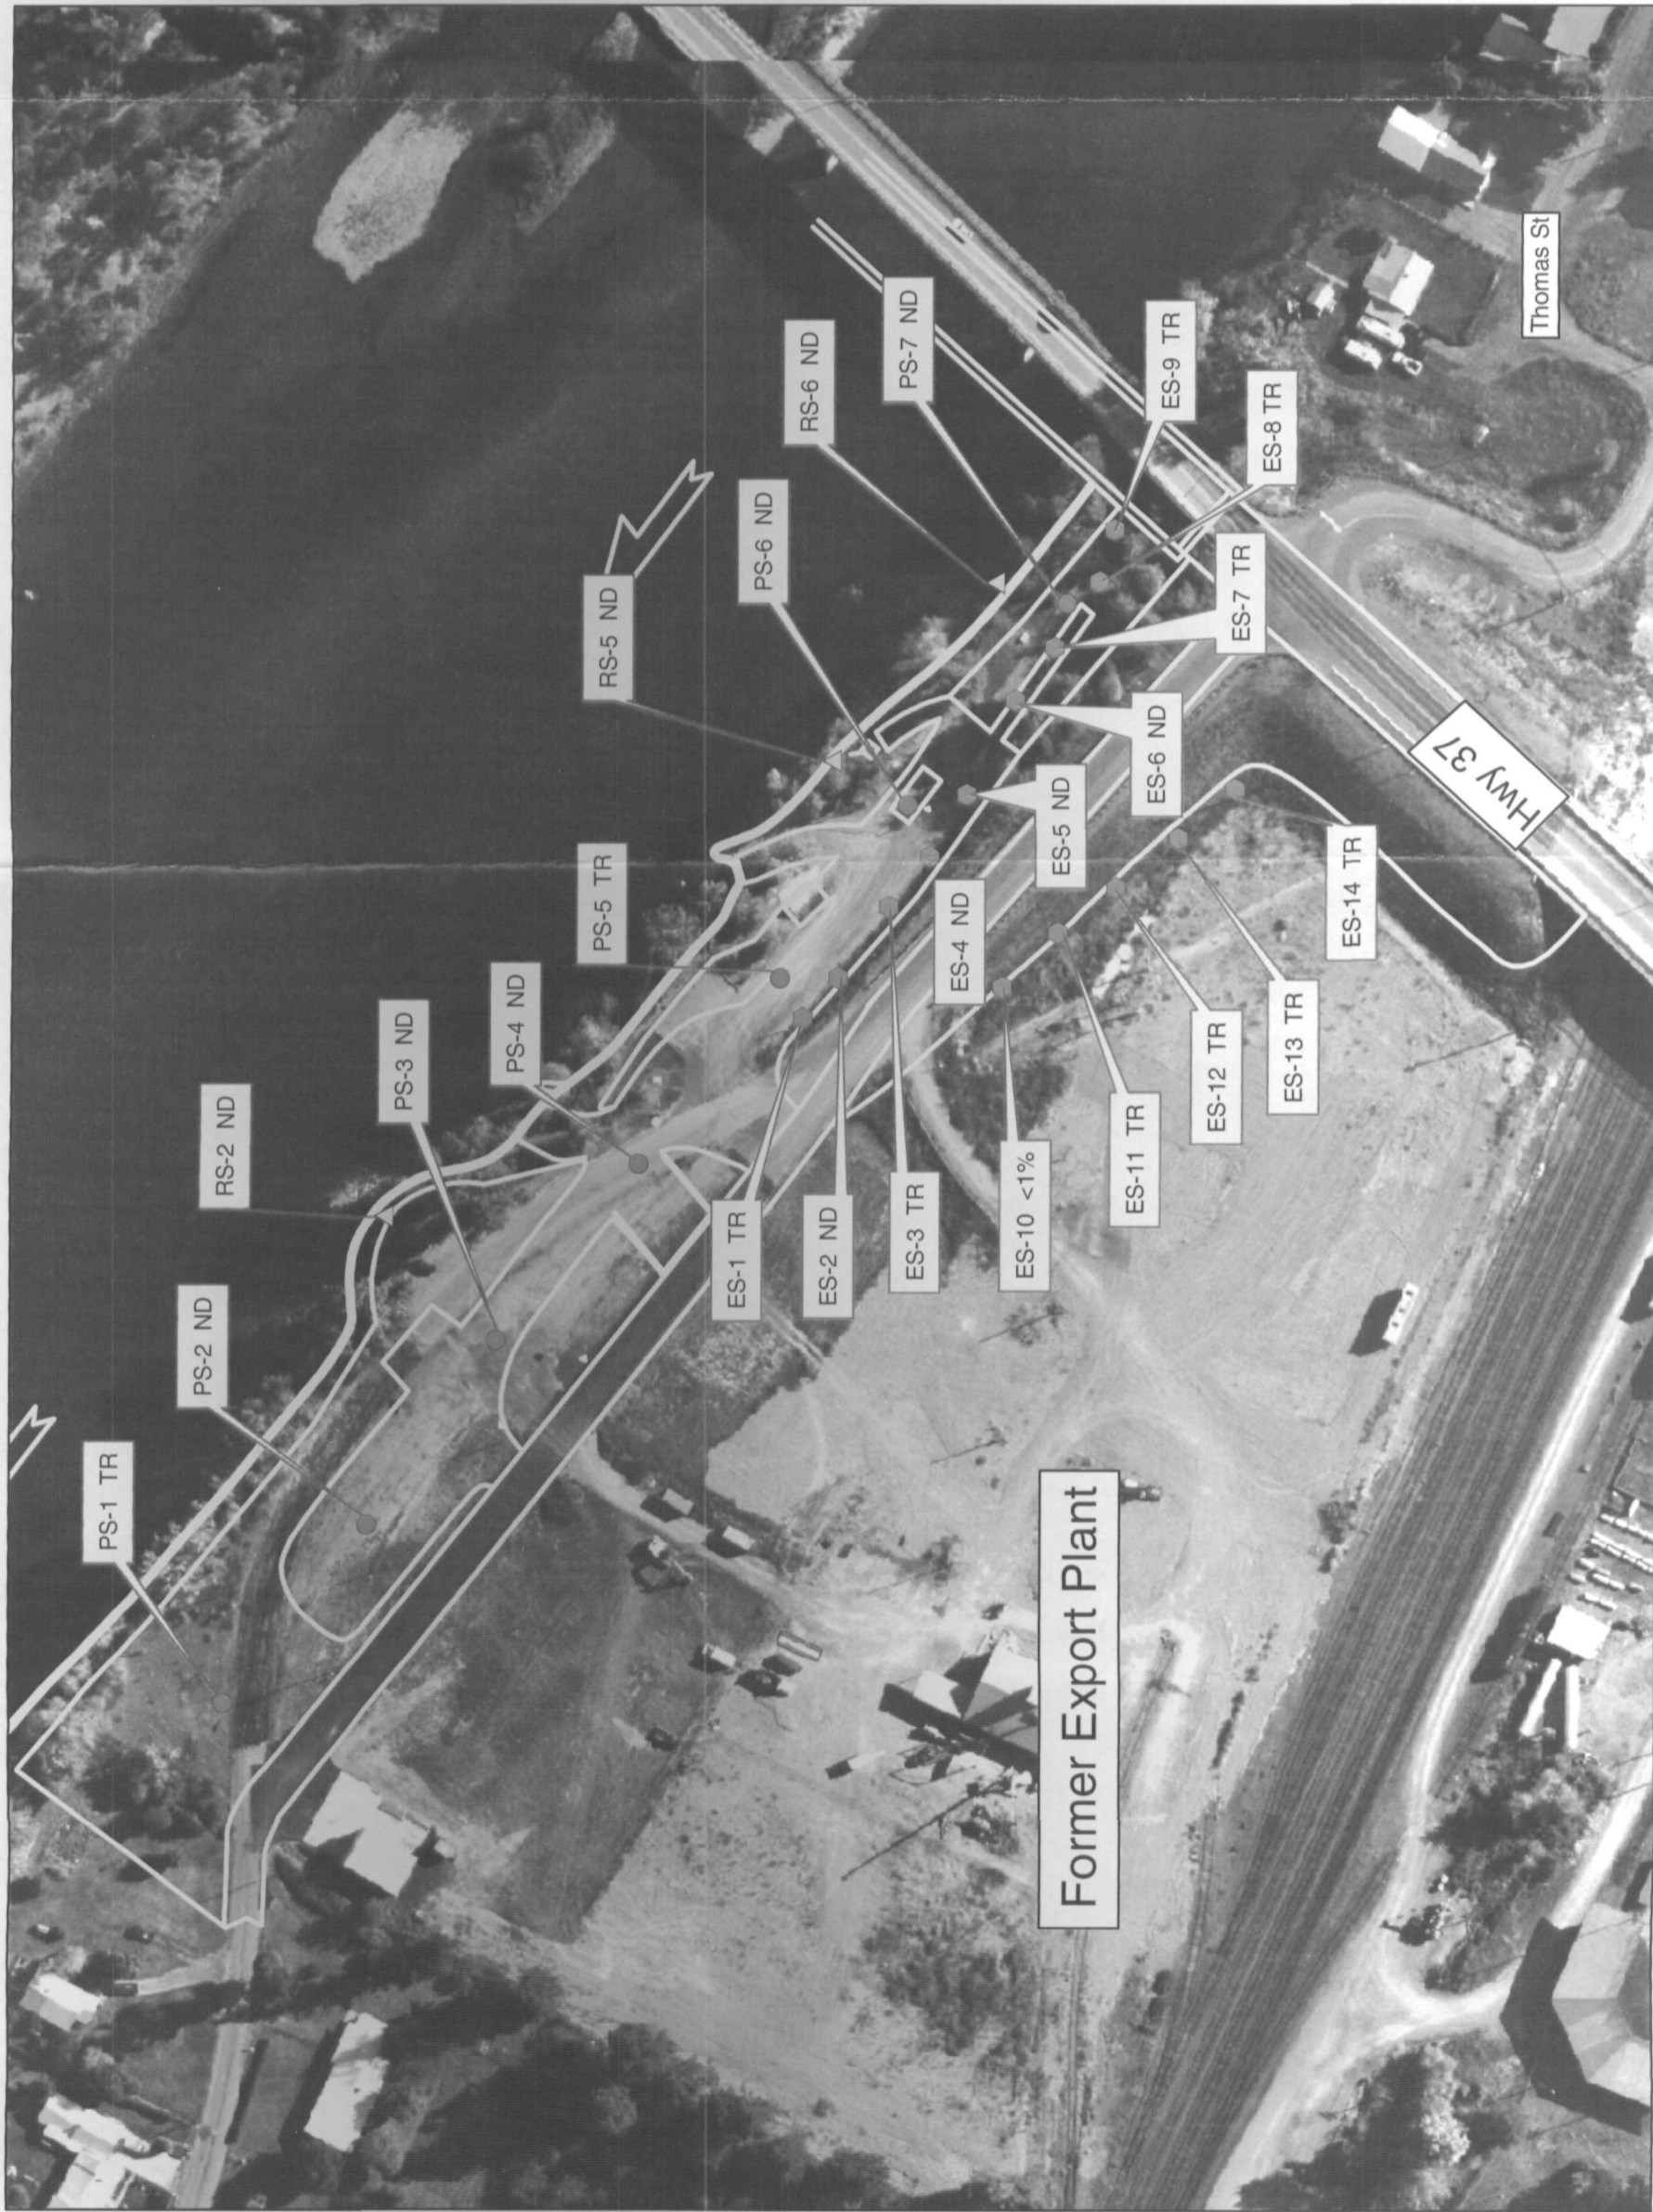
Figure 4-1
Surface Soil Sample Results
Riverside Park
Libby, Montana

Surface samples, generally located in areas without visible vermiculite, identified areas with trace to <1% Libby amphibole (LA) asbestos in several locations, including the North West end of the site, the South East end of the site, and along the South West side of the embankment of City Service Road.

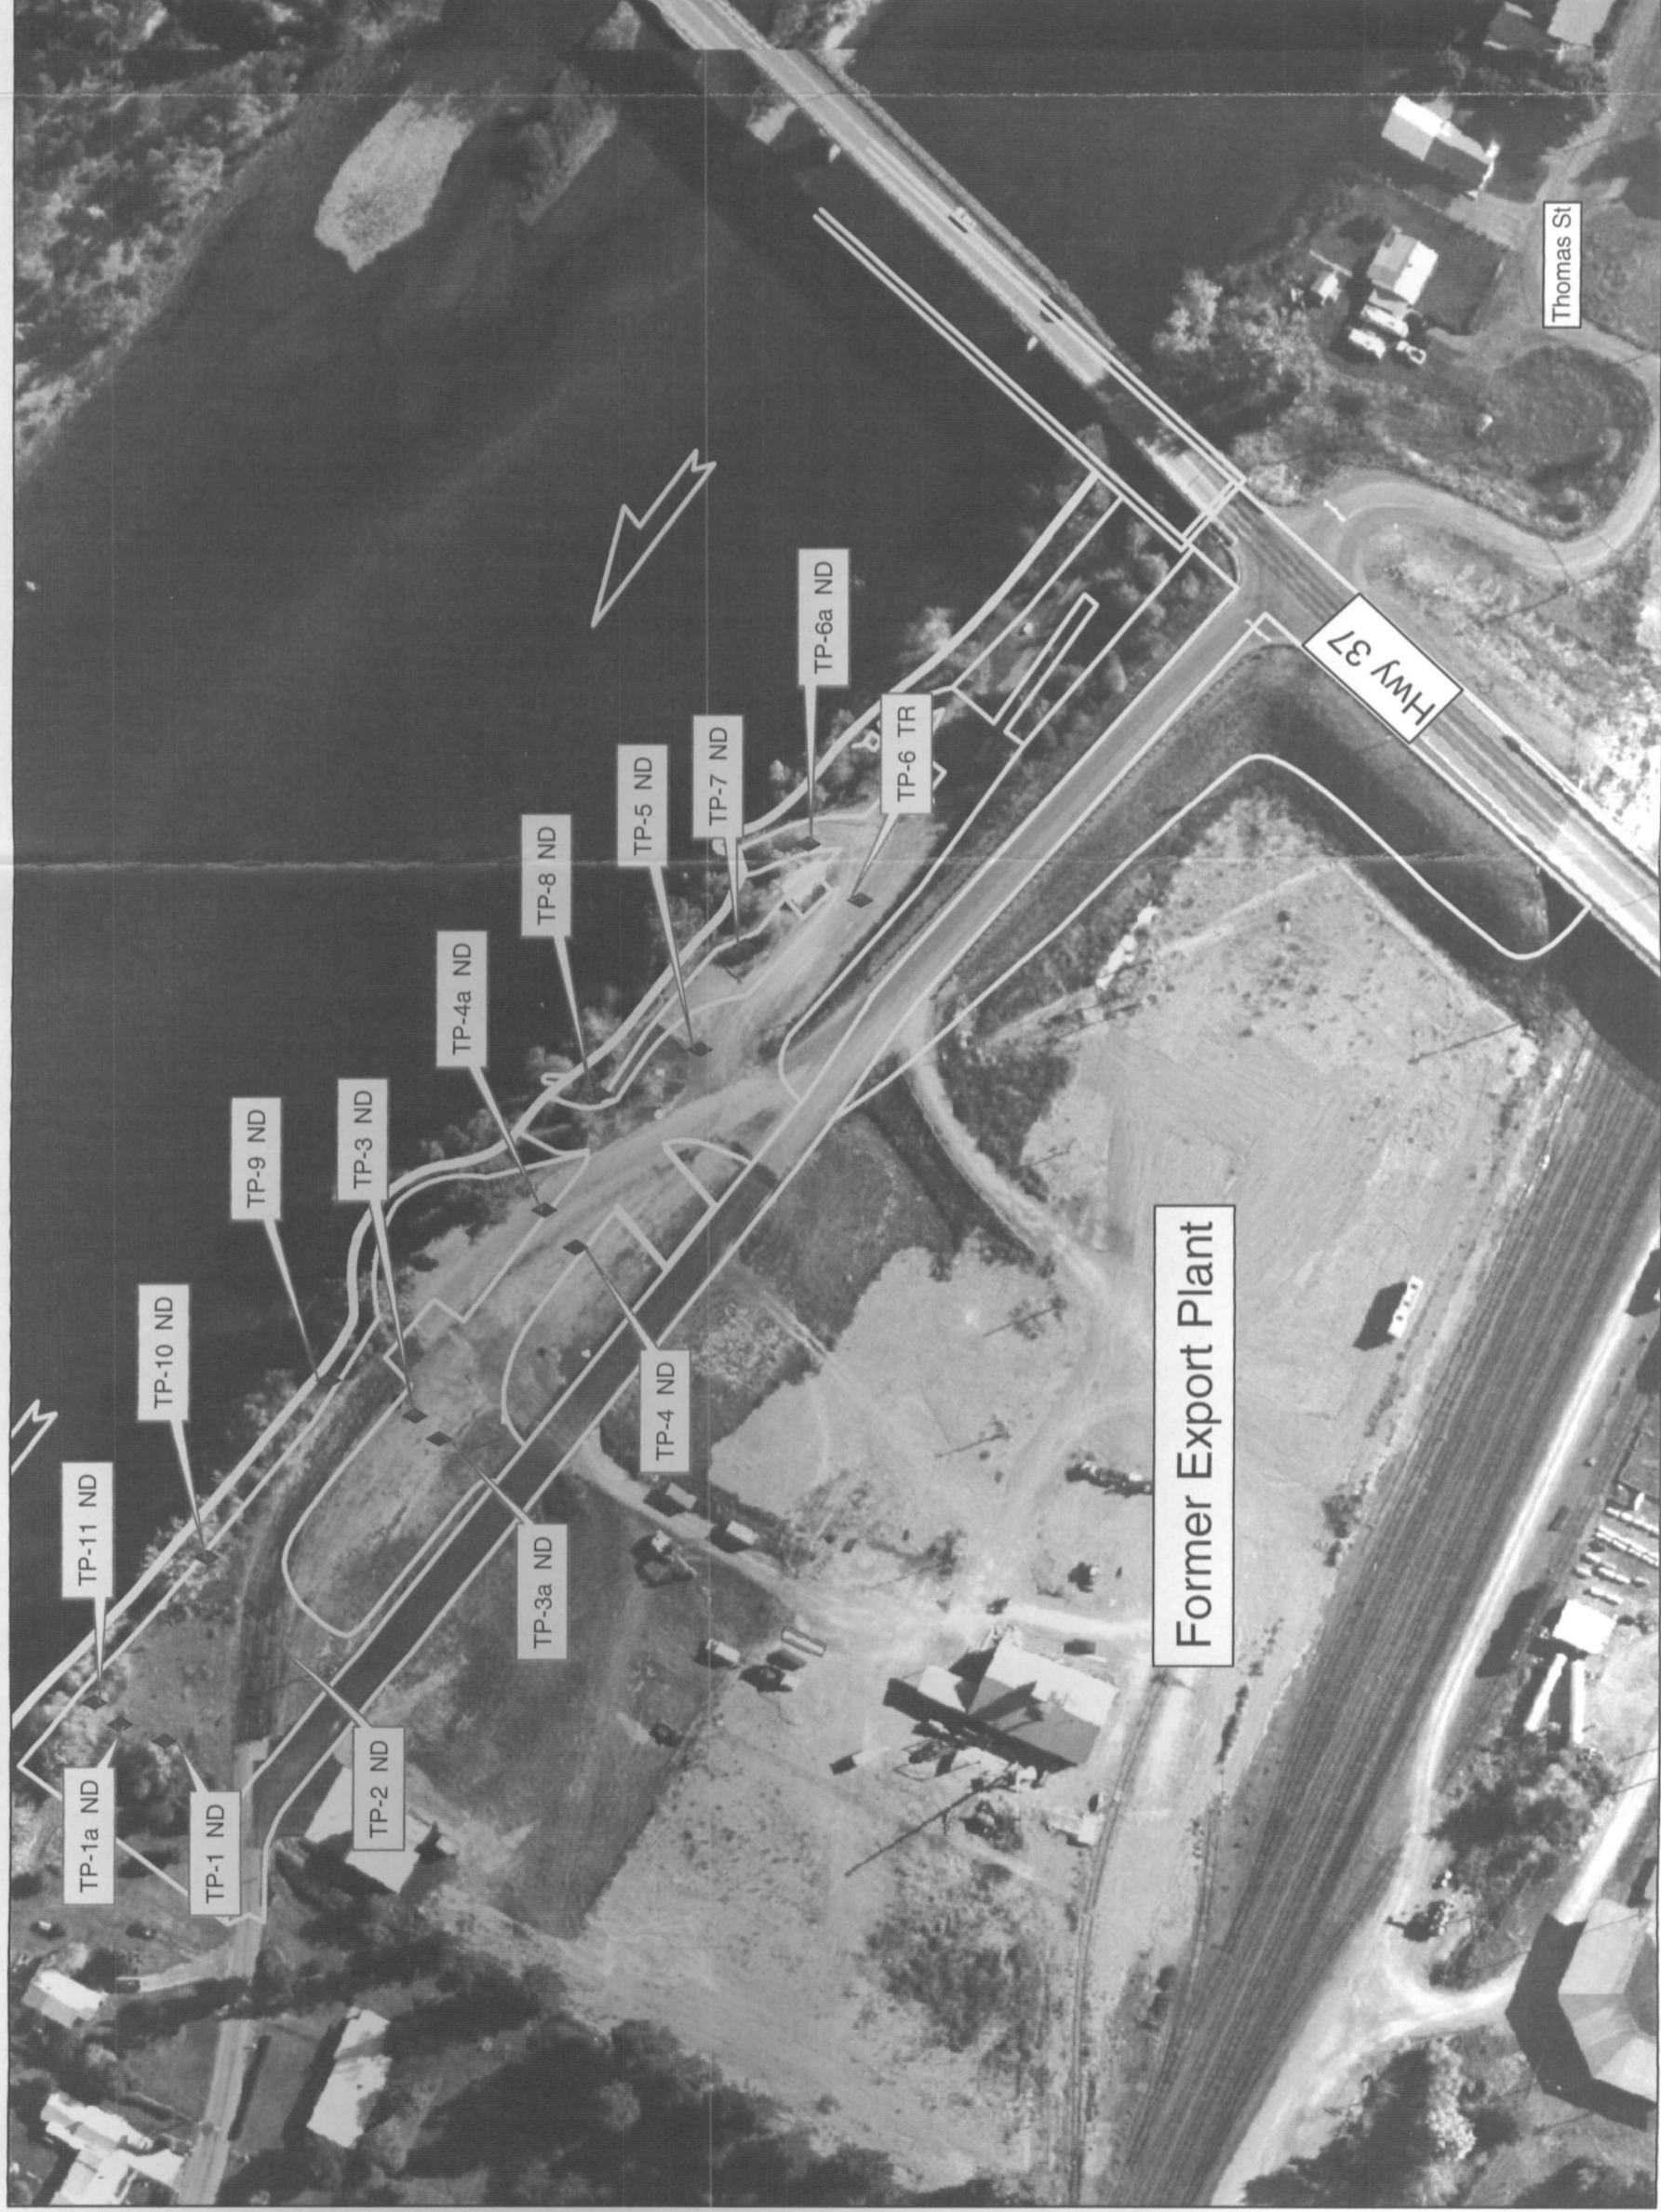
Figure 4-2
Sub-Surface Soil Sample Results
Riverside Park
Libby, Montana

Visual inspection of the test pits excavated at the site in areas of surficial visible vermiculite, found that visible vermiculite was located at depths up to 8 inches below ground surface (bgs). Sampling of the test pit soils below the depths of visible vermiculite and in areas without visible vermiculite found no LA asbestos with the exception of Test Pit 6, where a trace of LA asbestos was found.
